## Building Suite Survey Summary Report for:

1234 Sample Rd., Lake Mary, FL 32746, Suite 123

15148

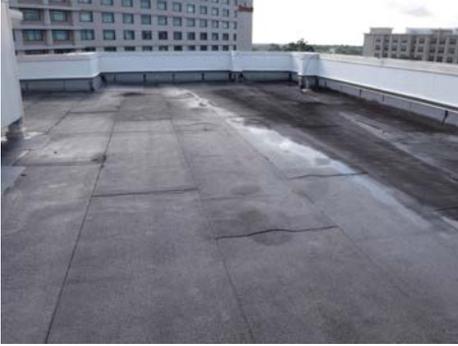
**Figure 2:** View of roof

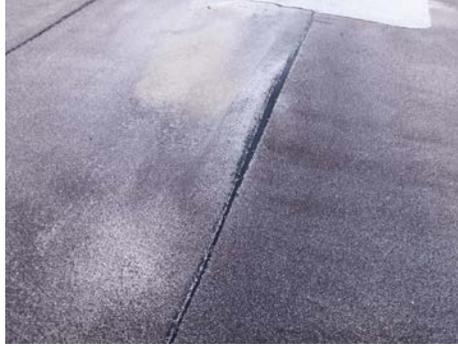
2. There were "blisters" in several areas of the modified bitumen roofing material over third floor. Although a leak from the roof may not directly have an affect on this suite, we recommend contacting building association for information on potential assessments and/or building maintenance reserve funds for repairs.

**Figure 3:** Bubbles forming under roofing material.

2. Evidence of current deterioration is evident by the numerous blisters present and previous patching. We did not perform a water tightness test on the roof system (the owners association may want to have qualified roofing contractor perform a water test is the method of determining whether this roof is in fact water tight.)
3. Roof drain pipes require regular periodic cleaning with a drain snake. We suggest having this service performed now, then every year as needed.

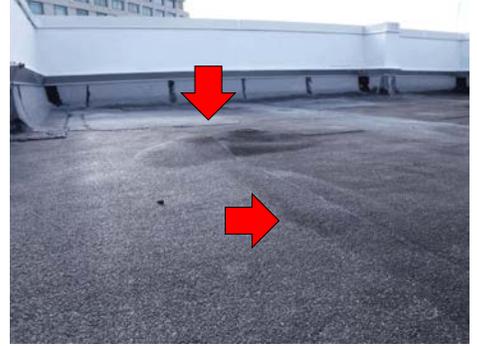
**Figure 4:** Large bubble over southeast corner of roof.

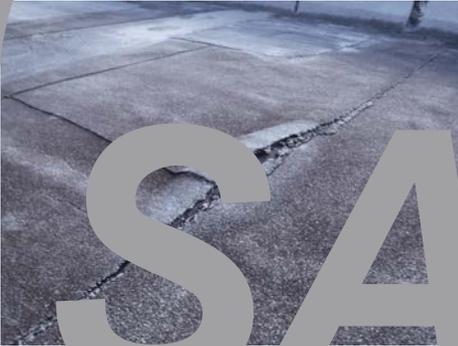
**Figure 5:** Hole spanning roof at seam.

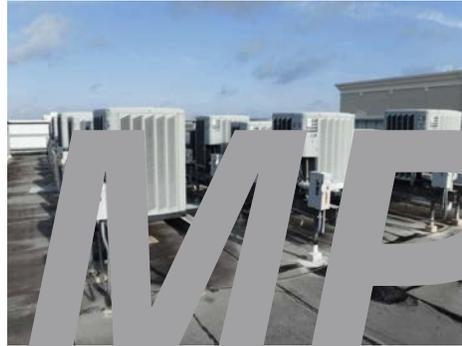
**Figure 6:** HVAC condensers on roof

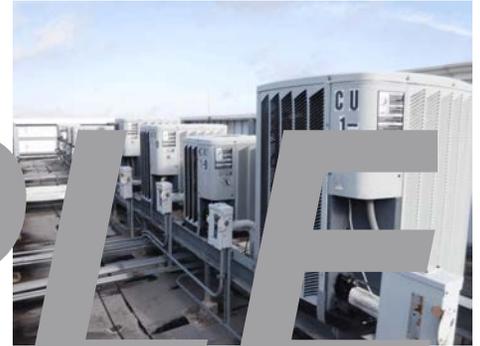
**Figure 7:** subject HVAC condenser with their numbering system

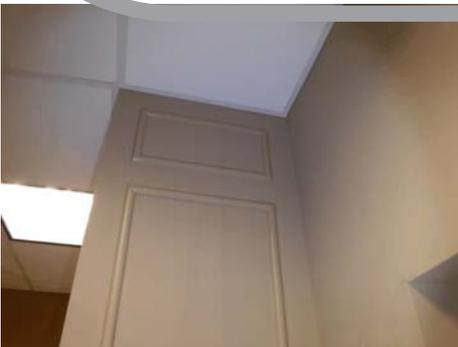
**Figure 8:** Dry water stains on the "column" left of reception window

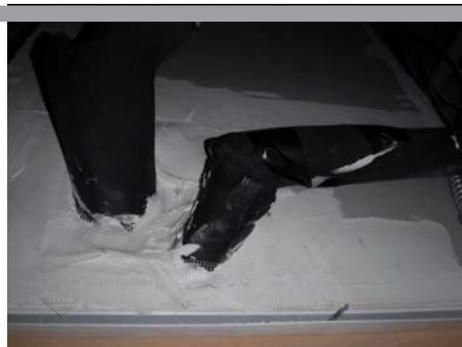
**Figure 9:** Water stains from HVAC condensate line above ceiling.

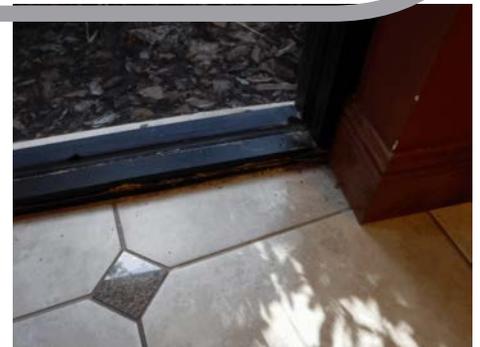
1. There were a few small voids in the window seals of the fixed glass windows on the east side of the suite. Water stains (intrusion) as a result at the base of the window frames of several offices on the east side (left side of suite if facing suite entry)

**Figure 10:** Evidence of previous water intrusion at windows on east side of suite.

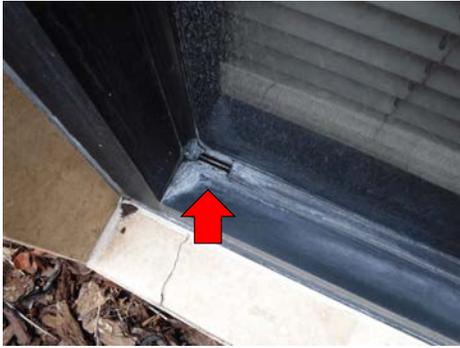
**Figure 11:** Voids in window seal may contribute to water intrusion.

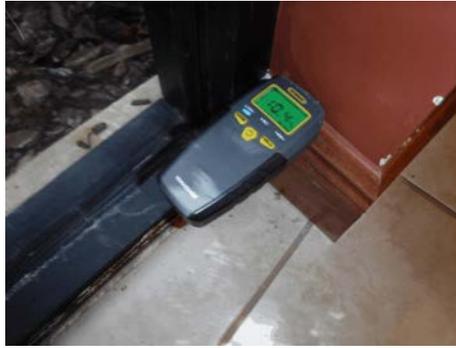
**Figure 12:** No elevated moisture at the time of inspection.

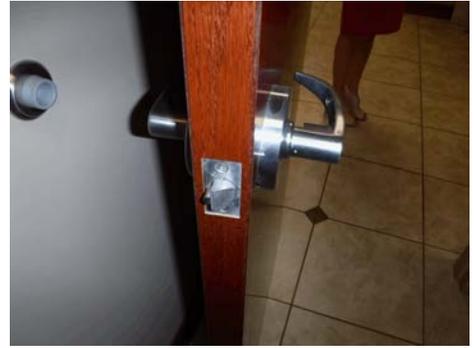
**Figure 13:** Utility closet door hardware does not have lock release, do not close without key

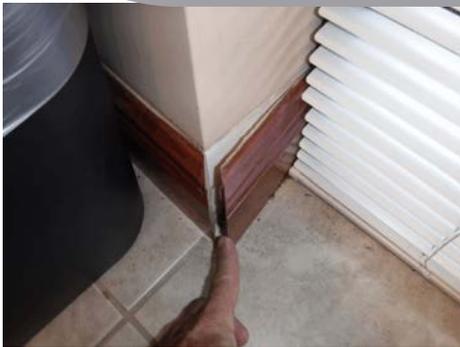
6. Loose wood base board right of refrigerator and right rear office

**Figure 17:** Loose base board in right rear office and right of refrigerator.

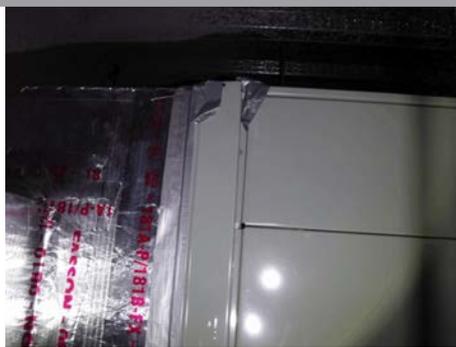
4. The evaporator coil, in the air handler, was dirty at the time of the inspection; this promotes an inefficient system that may put strain on the system and cause higher temperature differentials. Temperature differential was 26 degrees, higher than industry standard. Recommend having further evaluation.
5. There were dry water stains on the "common" drywall of the receptacle area. The stains may be from former condensation forming on the HVAC coil above the ceiling. There was an open hole in the pipe insulation.

**Figure 18:** Duct tape securing filter cover at HVAC air handler. Evaporator coil dirty.

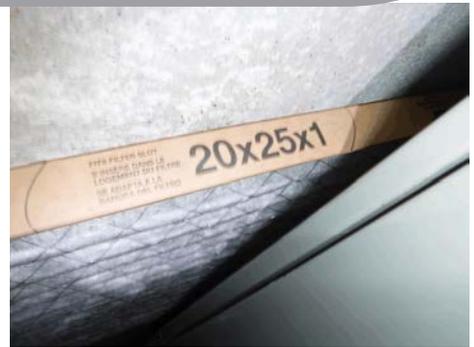
**Figure 19:** HVAC unit takes 20x25 filter.
