**CERTIFIED
BUILDING
INSPECTORS**

Date: July 30, 2019

**NEW HOME-PRE DRYWALL
INSPECTION REPORT FOR:
Jane Doe**

1234 Sample Rd. Lot 1
Winter Park, FL 32792

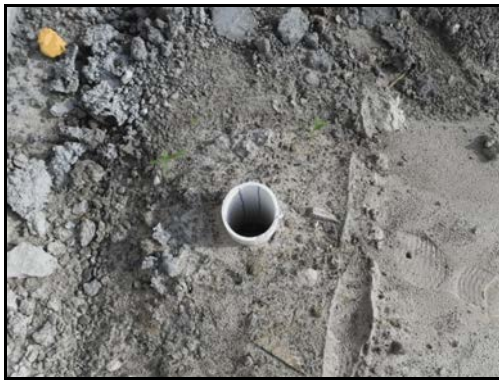
2. Missing sewer clean out

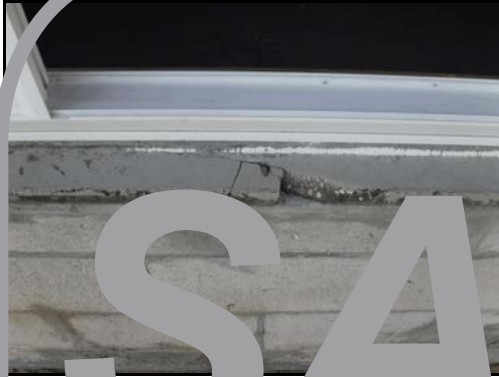
4. Damage to concrete window sill

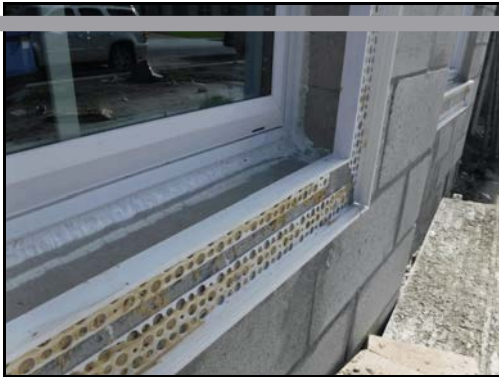
8. Make sure to maintain slope at stucco trim window sills

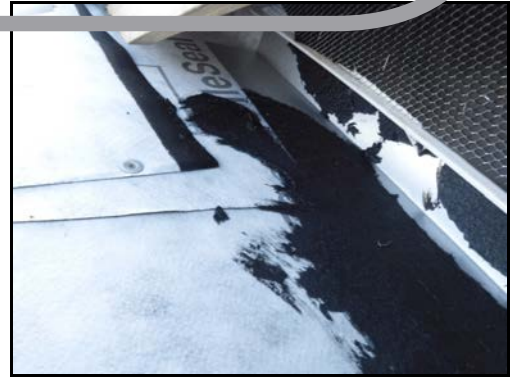
9. "L" flashing popped slightly on left side of front entry wall. No metal cap at top of soffit, like right side.

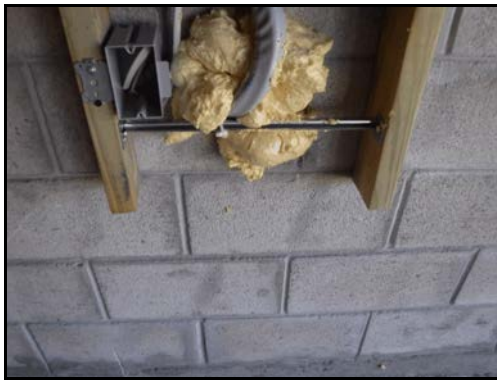
11. Recommend 2x4 at bottom of electrical panel box.

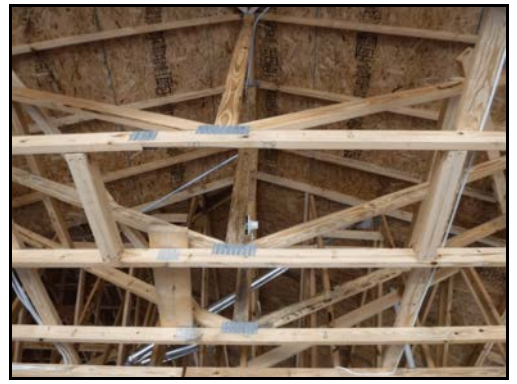
12. Plans call for receptacle above attic access in garage

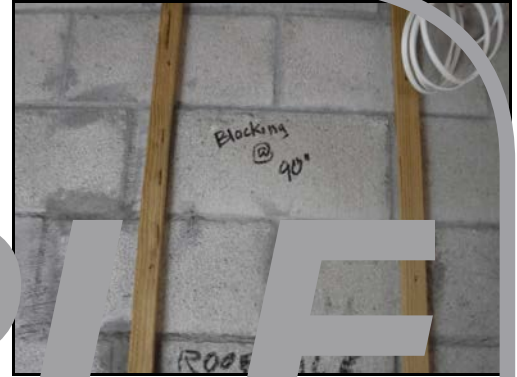
15. Not all blocking added at initial construction

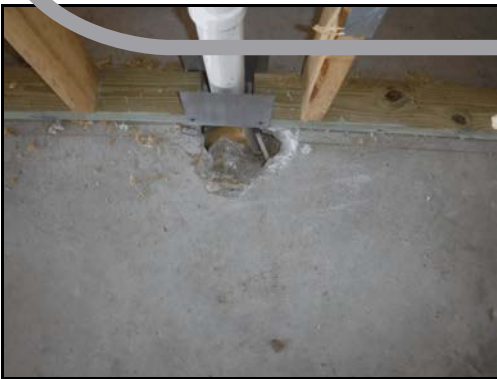
16. Void in concrete floor of laundry room and rear bedroom.

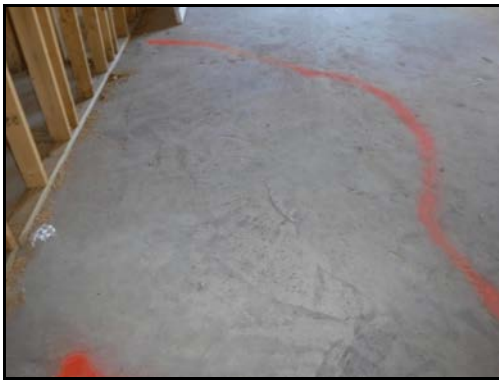
19. Large area of raised concrete in den, hall and family rooming

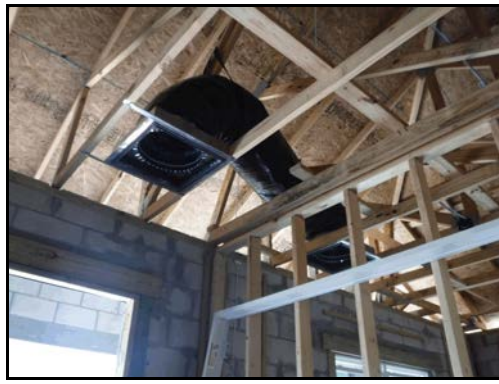
20. Master HVAC return vent not as per plan

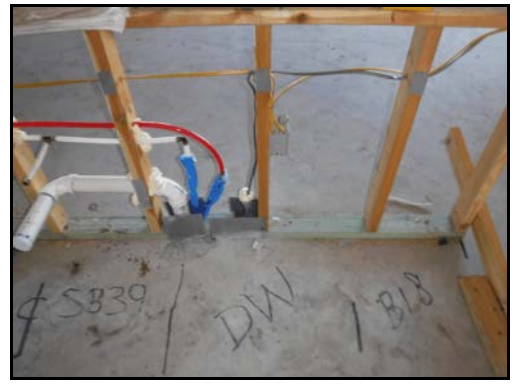
21. No power observed for dishwasher

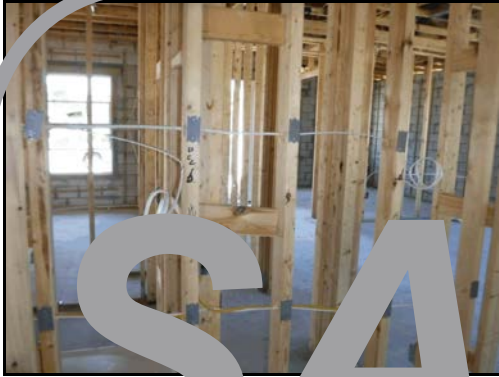
22. No blocking in den, hall and family rooming

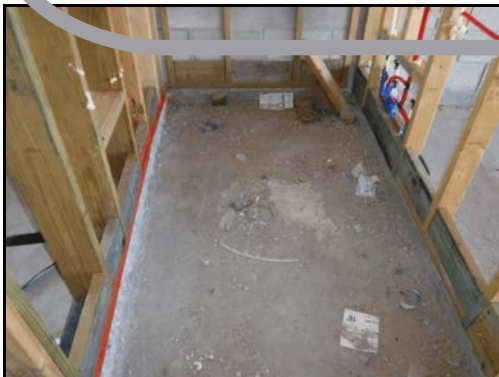
25. No pan in master shower

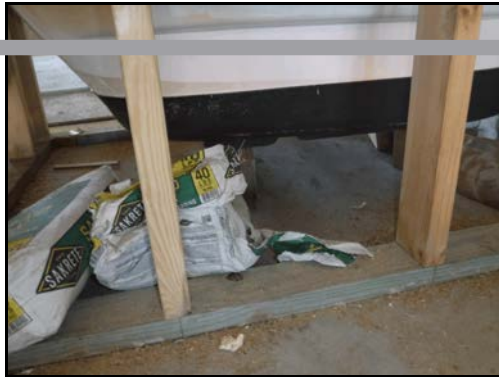
26. Master tub currently supported by wood blocks
