**CERTIFIED
BUILDING
INSPECTORS**

HOME INSPECTION REPORT FOR:

SUBJECT PROPERTY:

1234 Sample Rd.

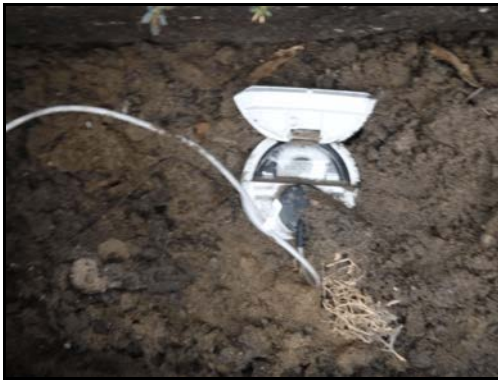
1. Movement at water meter leak detector.

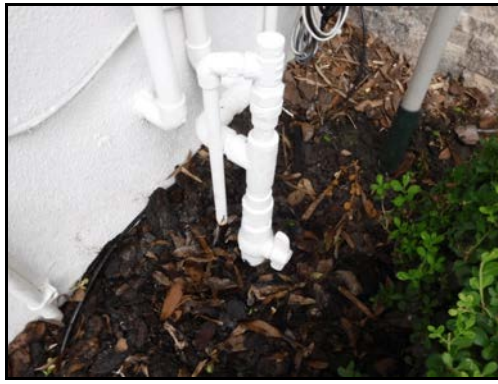
1. The following **Exterior** conditions;
 - A. Please See the WDO and Termite inspection report, that accompanies this report, for the reported Wood Deterioration. Wood damage may not be limited to the listed areas.
 - B. The gates to the rear yard were not self-closing,
 - C. Drain cover damaged in the yard right of the pool equipment
2. The following **Plumbing** conditions;
 - A. Constant water dripping from the pressure relief valve above the main water shut off,

2. Meter movement maybe water leaking from pressure relief valve at main water shut off.

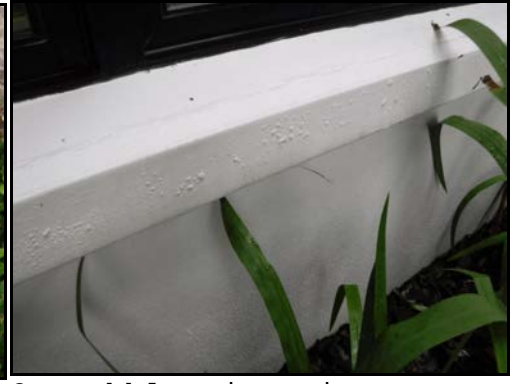
- Bubbles forming in the exterior paint at the window sills of the front right office.
- Gap under the garage door weather strip and floor.

3. Bubbles in paint at office window sill.

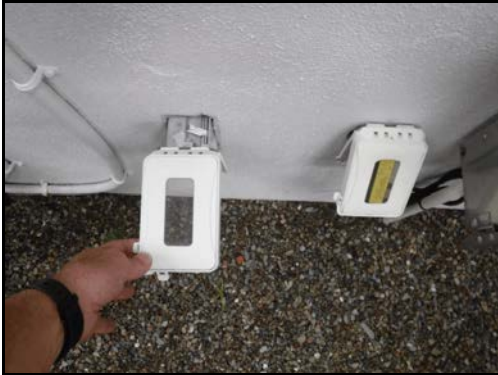
3. The following **Electrical** conditions;
 - A. The electrical box between the low voltage light box and the hot water heater was not secured to the house,
4. The following **Interior** conditions;
 - A. Missing locking pin for the front right guest bedroom door,
 - B. The right rear guest bedroom door did not catch strike plate,
5. The following **Pool** conditions;
 - A. The “Low salt” indicator light was illuminated on the salt cell at the pool equipment,
 - B. The pressure gauge on the filter did not appear to function,

4. Electrical box on right side of house not secure in wall.

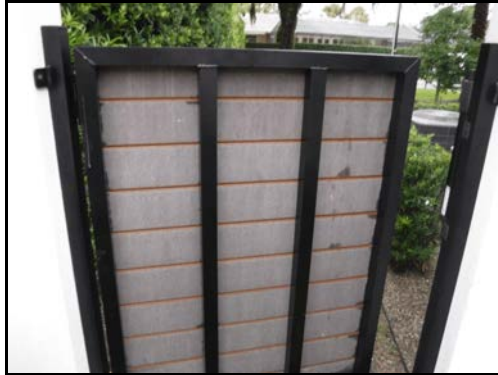
5. Latches to pool area do not self close.

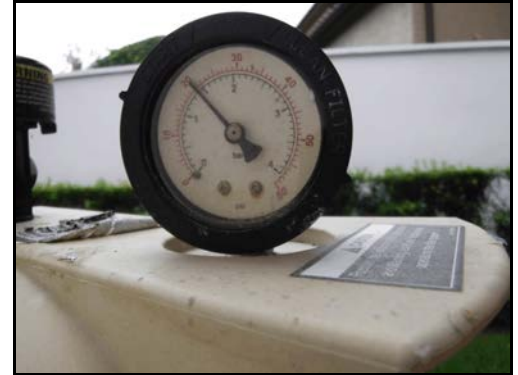
6. Pressure gauge at pool filter did not appear to function.

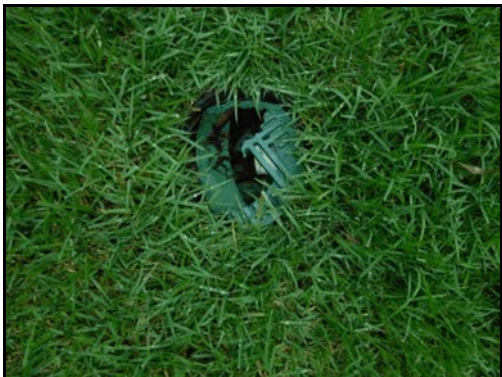
7. Damage to drain cover in right yard.

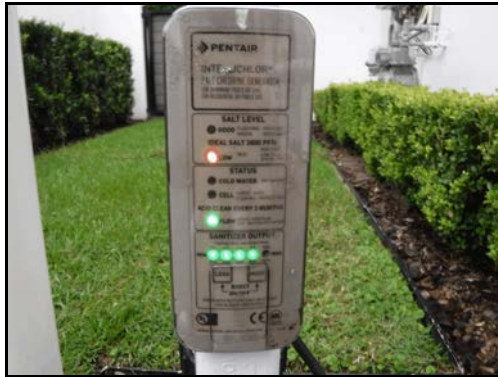
8. "Low salt" reading at pool equipment.

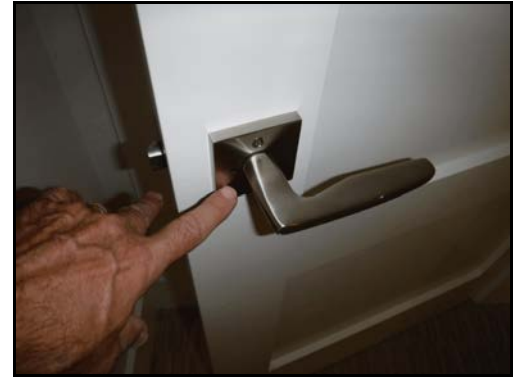
9. Missing lock pin in right guest bedroom door.
